NATIONAL TRANSPORTATION SAFETY BOARD
Office of Aviation Safety
Washington, D.C. 20594

AIRWORTHINESS GROUP CHAIRMAN'S FACTUAL REPORT

NTSB No: WPR14FA137

Operator: Helicopters, Incorporated
Aircraft: Airbus Helicopters AS350 B2, Registration N250FB
Location: Seattle, Washington
Date: March 18, 2014
Time: 0740 Pacific daylight time

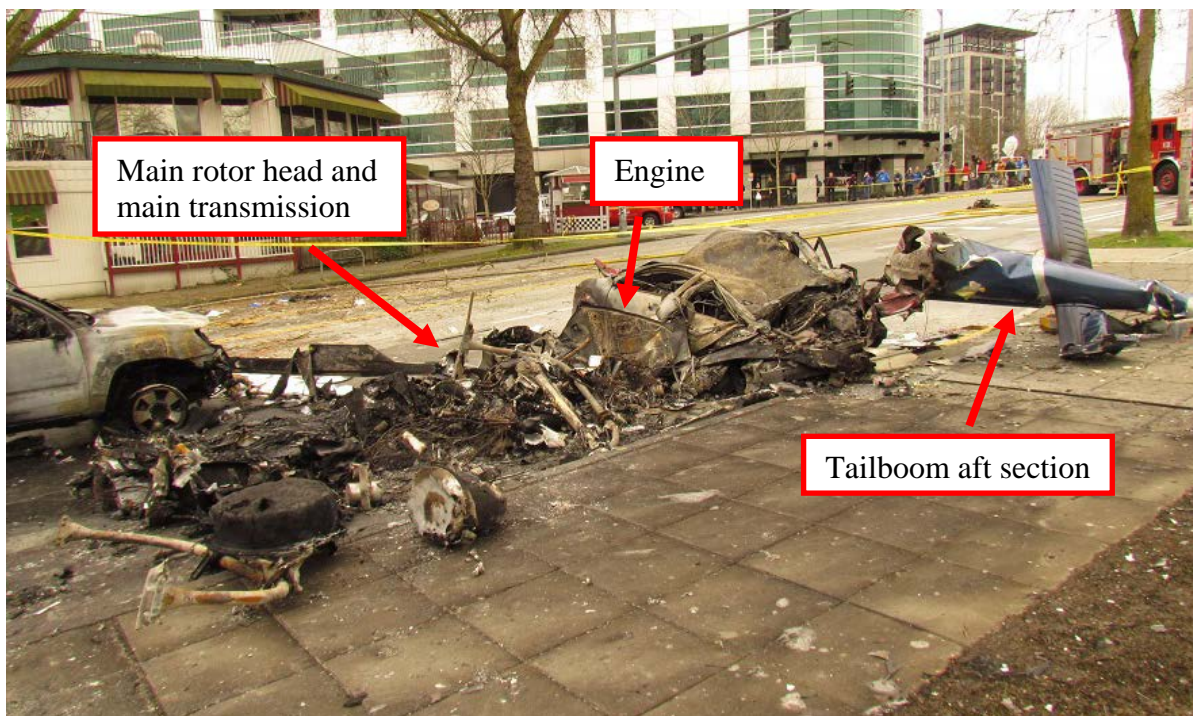
The helicopter came to rest on its right side oriented on a magnetic heading of about 50°. The majority of the main cabin and forward section of the tailboom were either exposed to or consumed by the post-crash fire (**Photo 1**). The remainder of the tailboom was found adjacent to the main wreckage and did not exhibit heat damage from the post-crash fire. The right horizontal stabilizer exhibited crushing deformation consistent with ground impact forces. The left horizontal stabilizer did not exhibit evidence of damage. The areas forward and aft of the horizontal stabilizer exhibited signatures of deformation. The vertical fin remained attached to the tailboom and exhibited signatures of slight deformation damage. Several fragmented pieces of the cockpit instruments were found in the wreckage but were either severely heat distressed or consumed by the post-crash fire.

Photo 1. The accident site.

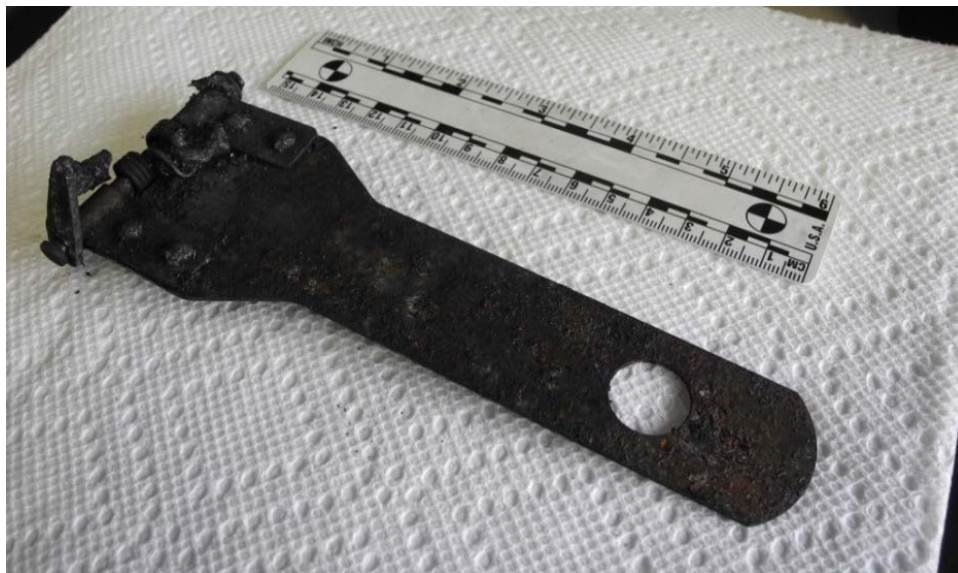
Photo 2. The recovered collective locking plate.

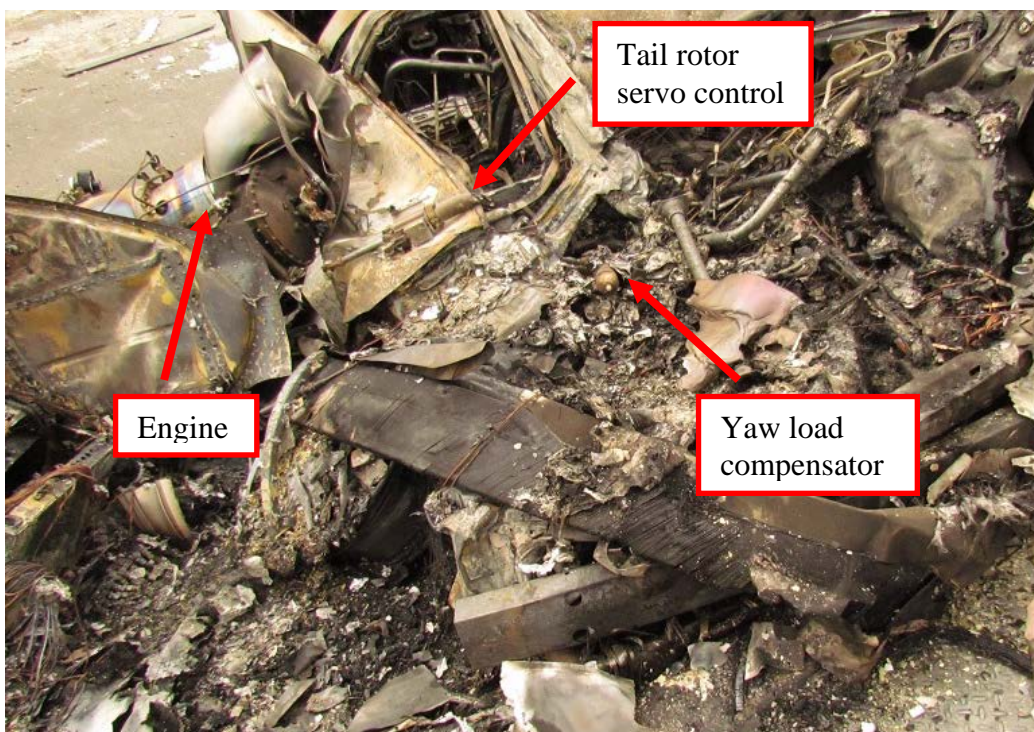
The tail rotor servo control was found immediately aft of the engine (**Photo 4**). The aft end of the tail rotor servo control was melted and the servo as a whole exhibited thermal damage. All attaching hardware on the tail rotor servo piston rod end and the servo input lever were present. The control linkage to the servo input lever was consumed by the post-crash fire. The yaw load compensator was found aft of the tail rotor servo and exhibited heavy thermal damage.

Photo 4. Tail rotor servo control and yaw load compensator as found at the accident scene.

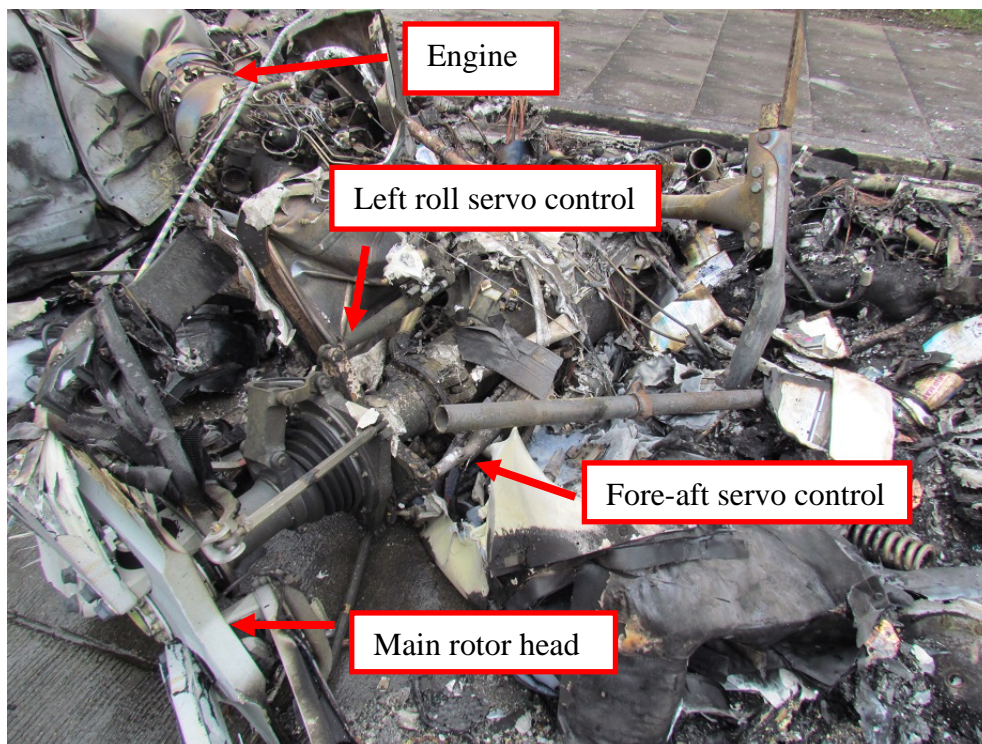
The left roll, right roll, and fore-aft [main rotor] servo controls were found attached to the stationary swashplate and the main transmission housing (**Photo 5**). Both left roll and right roll servo controls exhibited heavy sooting and exhibited signatures of heat distress. The upper housing of the fore-aft servo control was partially fractured and the servo control exhibited signatures of heat distress. The accumulators remained attached to all three main rotor servo controls. The control linkages were mostly consumed by the post-crash fire, but the attaching hardware connecting the control linkages to the main rotor servo control input levers were found in their installed positions. All hydraulic lines connecting to the servo controls were consumed by the post-crash fire. The hydraulic pump and hydraulic distribution block were recovered and exhibited thermal damage. The hydraulic pump belt and the hydraulic reservoir were consumed by the post-crash fire.

Photo 5. Main rotor servo controls as found at the accident scene (right-roll servo control hidden in this photo).

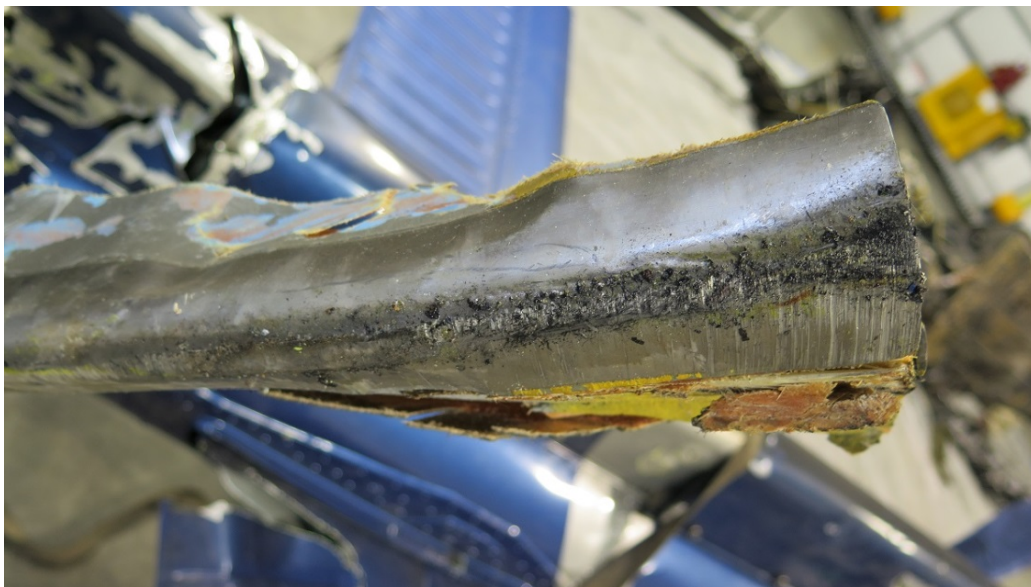
The tail rotor blade pitch control links remained attached between the pitch change horn and the pitch change spider. The two tail rotor blades remained attached to the tail rotor yoke. The first tail rotor blade exhibited splintering and fragmentation, consistent with high rotational energy impact damage, on its outboard half of the blade. The leading edge of the first tail rotor blade exhibited scuff marks, wrinkling at the leading edge, and a flattened appearance with traces of yellow paint overlaid on the tip of the leading edge. Yellow paint of similar color was also observed on the blade skin adjacent to the leading edge (**Photo 6**). Similar yellow colored paint

Photo 6. The leading edge tip end damage on the first tail rotor blade.

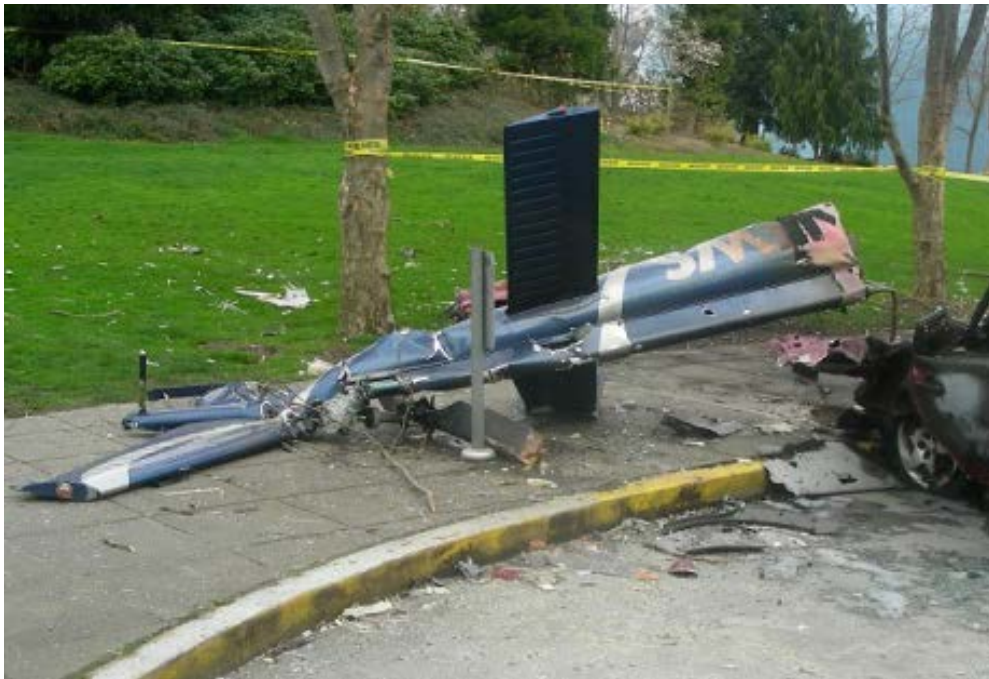
was observed to be on the street curb where the helicopter came to rest (**Photo 7**). The second tail rotor blade exhibited cracks on the blade skin adjacent to the leading edge, deformation of its leading edge on the outboard half of the blade, and chordwise scratches on the blade skin (**Photo 8**). The leading edge of the second tail rotor blade exhibited impact marks consistent with high rotational energy, with the severity of the scuff marks increasing going outboard of the blade.

Photo 7. The yellow curb adjacent to the resting position of the tailboom.

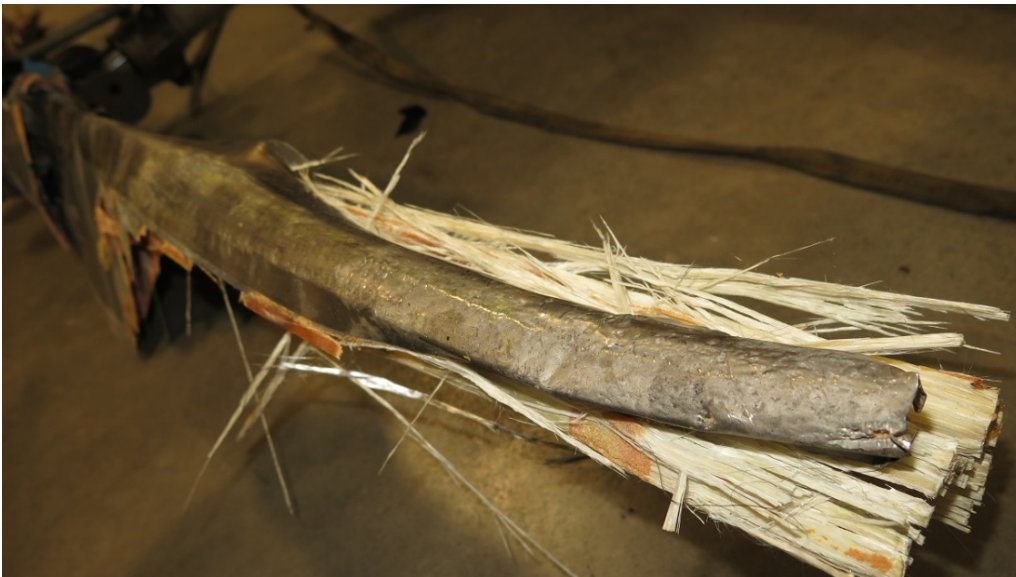
Photo 8. The leading edge damage on the second tail rotor blade.

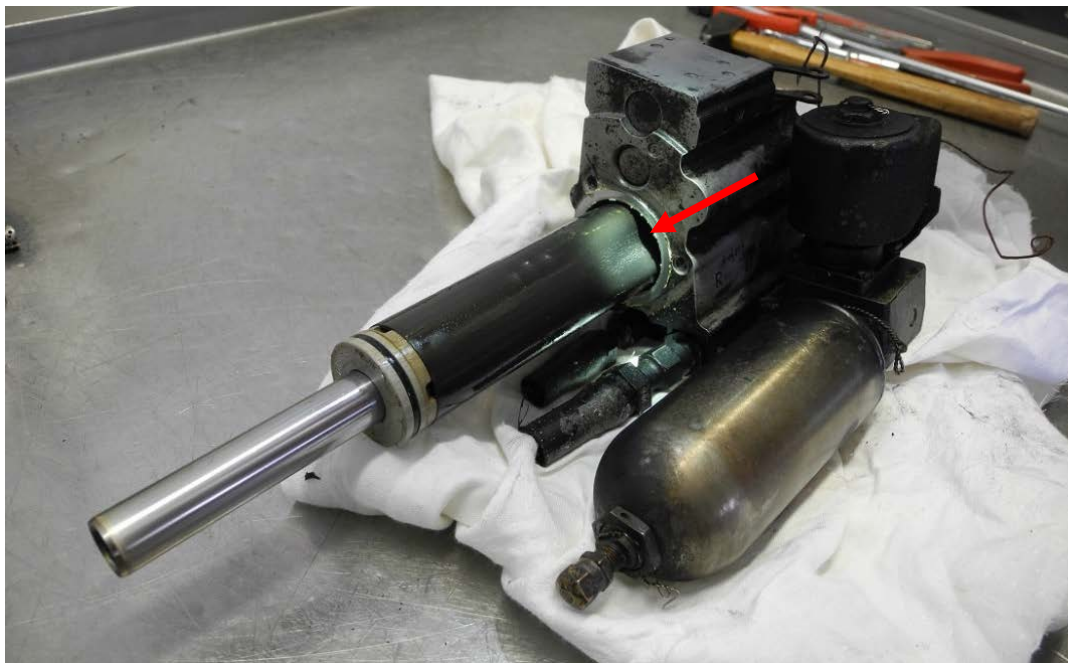
The piston rod of the left roll servo control visually did not exhibit bending deformation. The rod end threads exhibited no evidence of thread wear, but did exhibit small nicks consistent with impact damage. The piston rod was removed from the servo control and the piston liner was removed and confirmed to have deformation damage (**Photo 9**). A tan-colored liquid remnant was observed within the piston housing; the piston housing contained a brown-colored residue on its interior surface. A green-colored residue was observed on the central area of the piston surface. The control input locking pin was visually confirmed to be in the locked position. The locking pin contained small, reddish-tan colored globules, the source of which was unidentifiable at the time of the component examination (**Photo 10**). The servo control filter screen contained a wet, black colored residue on its surface. The sliding valve was removed and exhibited no evidence of gouges, but the surfaces exposed to the hydraulic ports exhibited a residue similar to that found on the filter. The sliding valve sleeve had a clean appearance with no evidence of damage.

Photo 9. Deformation of the piston liner of the left roll servo control (red arrow).

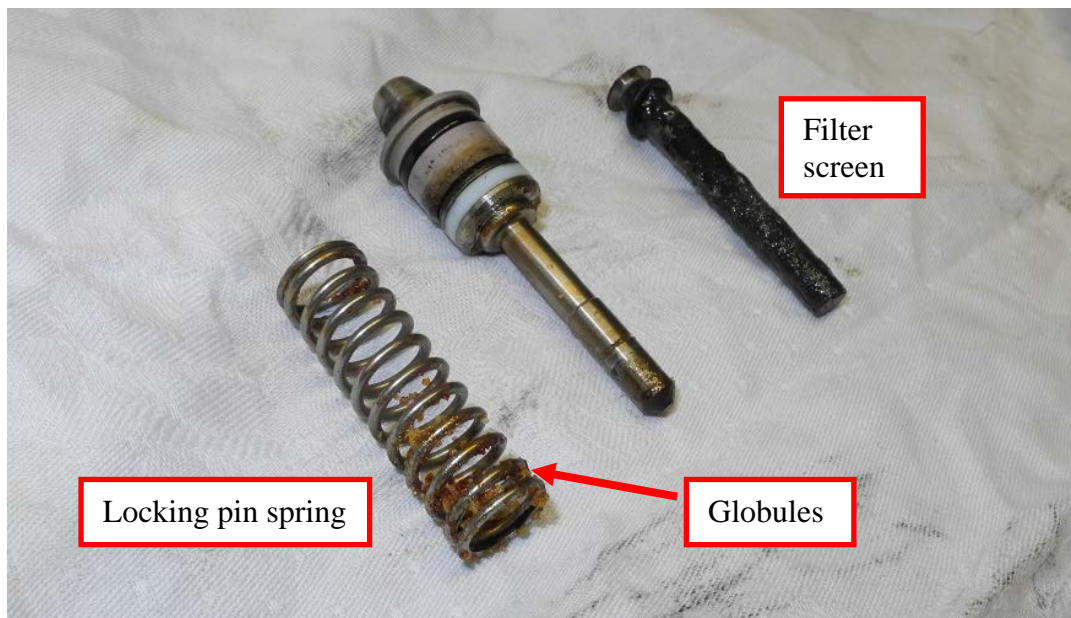
Photo 10. Residue found on the locking pin spring and filter screen.

The reddish-tan color globules found on the locking pin spring of the left roll and right roll servo controls were analyzed by the NTSB Materials Laboratory in Washington DC. A sample of globules taken from the left servo control was sent to an independent, third-party laboratory for analysis, which found the presence of four aluminum hydroxides and magnesium hydroxide, consistent with corrosion

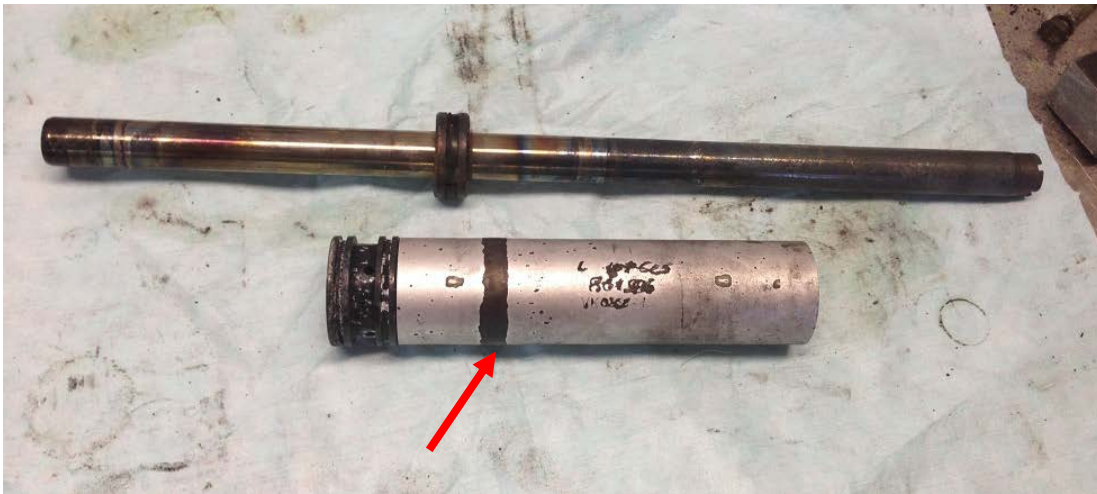
The piston rod and piston liner exhibited evidence of heat distress. A dark-colored band was observed on the piston liner about 3.70 inches from the aft end of the piston liner; the dark-colored band was relatively the same width as the piston head ([Photo 11](#)). The locking pin was visually confirmed to be in the locked position. The locking pin, spring, and filter screen exhibited evidence of heat distress ([Photo 12](#)). The sliding valve exhibited no evidence of gouges, but exhibited sooting and oxidation products on the surfaces exposed to the hydraulic ports ([Photo 13](#)). The sliding valve sleeve was damaged during removal from the servo control.

Photo 11. The dark-colored band observed on the piston liner (red arrow).

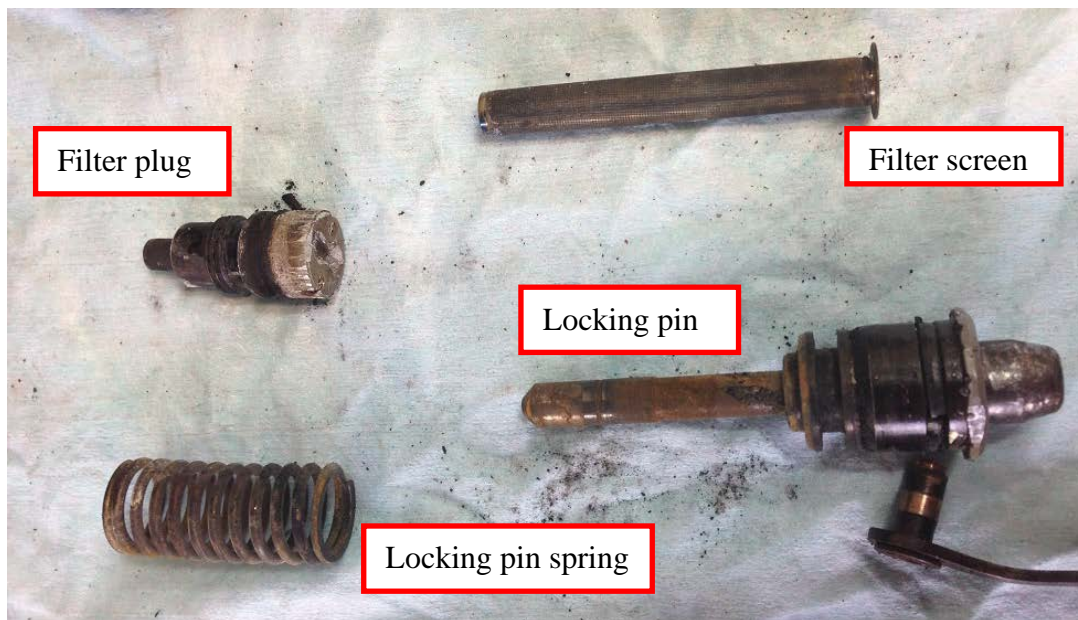
Photo 12. Locking pin, locking pin spring, filter screen, and filter plug for the tail rotor servo control.

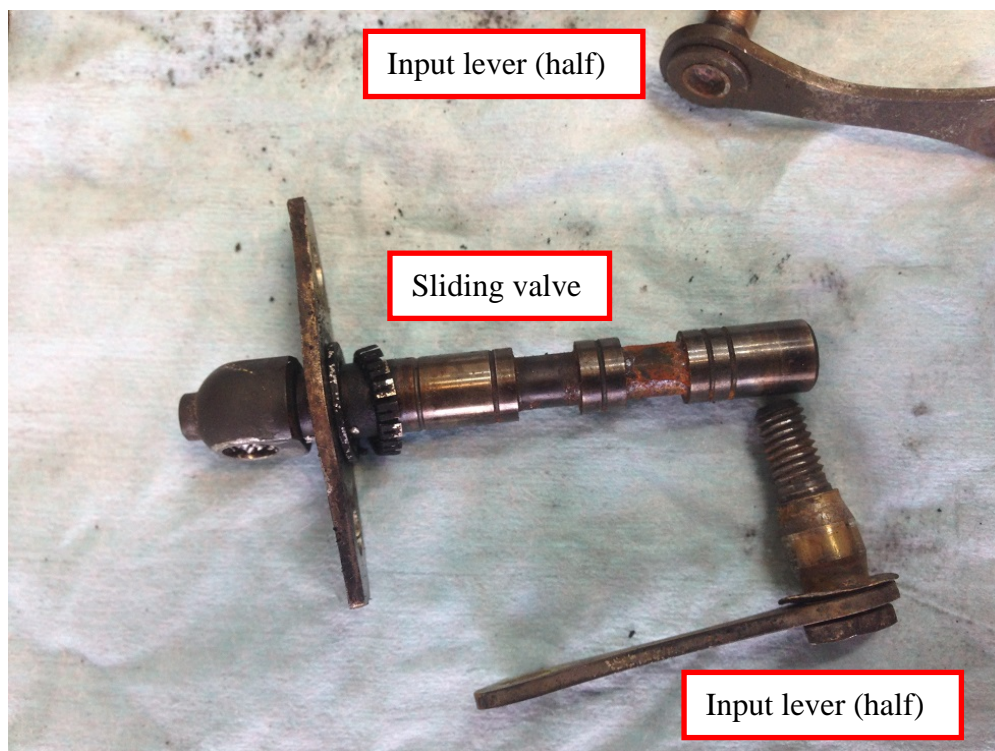
Photo 13. The sliding valve and input lever halves from the tail rotor servo control.

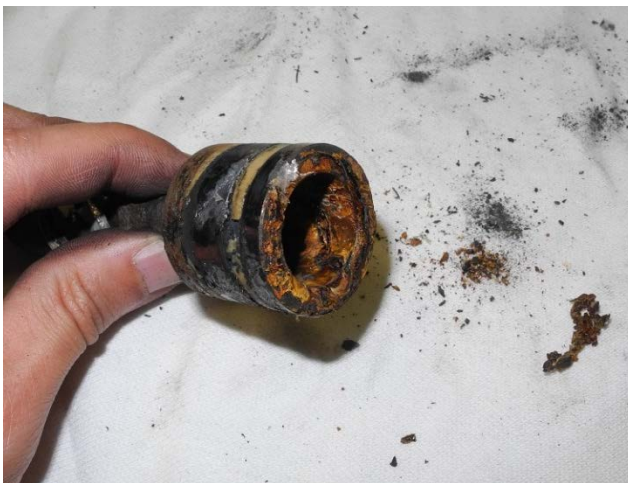
The yaw load compensator exhibited signatures of heat distress. The inner surfaces of the output piston and piston bore, both of which contacts hydraulic fluid, exhibited surface oxidation (**Photos 14 and 15**). The output piston scraper seals were present but only partially continuous on their circumference. The solenoid was disassembled and its electrical connections appeared secured. The solenoid piston exhibited no evidence of cracks, but did exhibit signatures of heat distress primarily on its lower surface contacting the hydraulic port (**Photo 16**). The solenoid piston's outer and inner springs were present, with the outer spring exhibiting heat distress. The outer spring was measured to be about 0.55 inches in length. No evidence of blockages was found in the solenoid piston hydraulic port.

Photo 14. Output piston exhibiting surface oxidation.

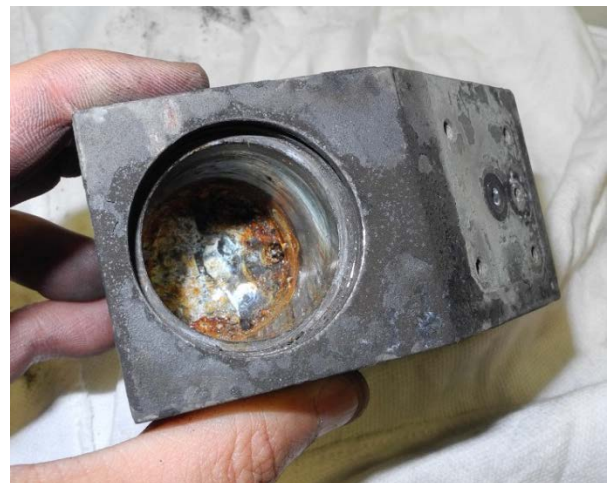
Photo 15. Output piston bore exhibiting surface oxidation.

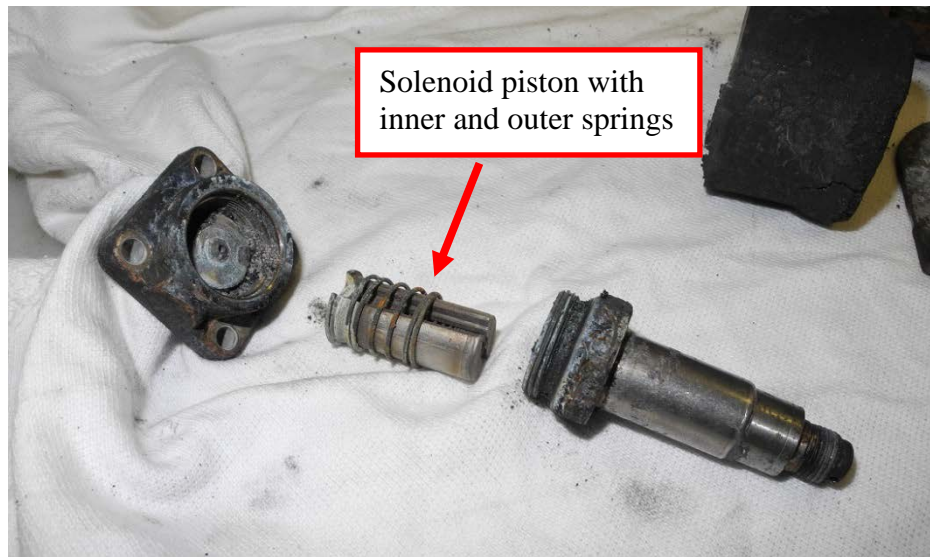
Photo 16. Disassembled solenoid from the yaw load compensator.
